Corzino

Vues éclatées

CAD	revize	Název	
			A	REHAB BUGGY - CNB CHASSIS	
		Datum	Jméno	číslo výkresu	měřítko
		23.04.2021		SVR00021AA	1:5
		konstroval		AROP-číslo	Hmotnost
		kontroloval		CNB 30, 34, 38, 42	-
		schválil			ISO A3

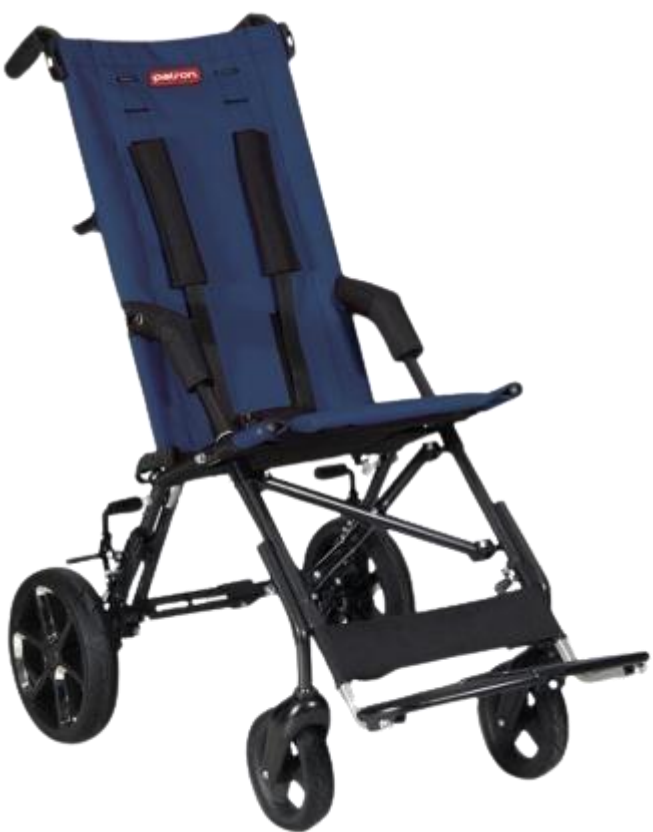
Pos.	Description	Side / Comments
1	Front leg	RI
2	Front leg	LE
3	Backrest	RI
4	Backrest	LE
5	Rear leg	RI
6	Rear leg	LE
7	Housing	pair
8	Front cross	-
9	Rear cross	-
10	Footrest	-
11	Front fork	-
12	Front wheel	-
13	Rear wheel	-
14	Roof attachment	-
15	Handle grip	pair
